# Parametric analysis of groundshock loading on steel plates and reinforced concrete slabs

Thesis submitted to the University of Sheffield  
for the degree of Doctor of Philosophy

**University of Sheffield**  
**Department of Civil and Structural**  
**Engineering**

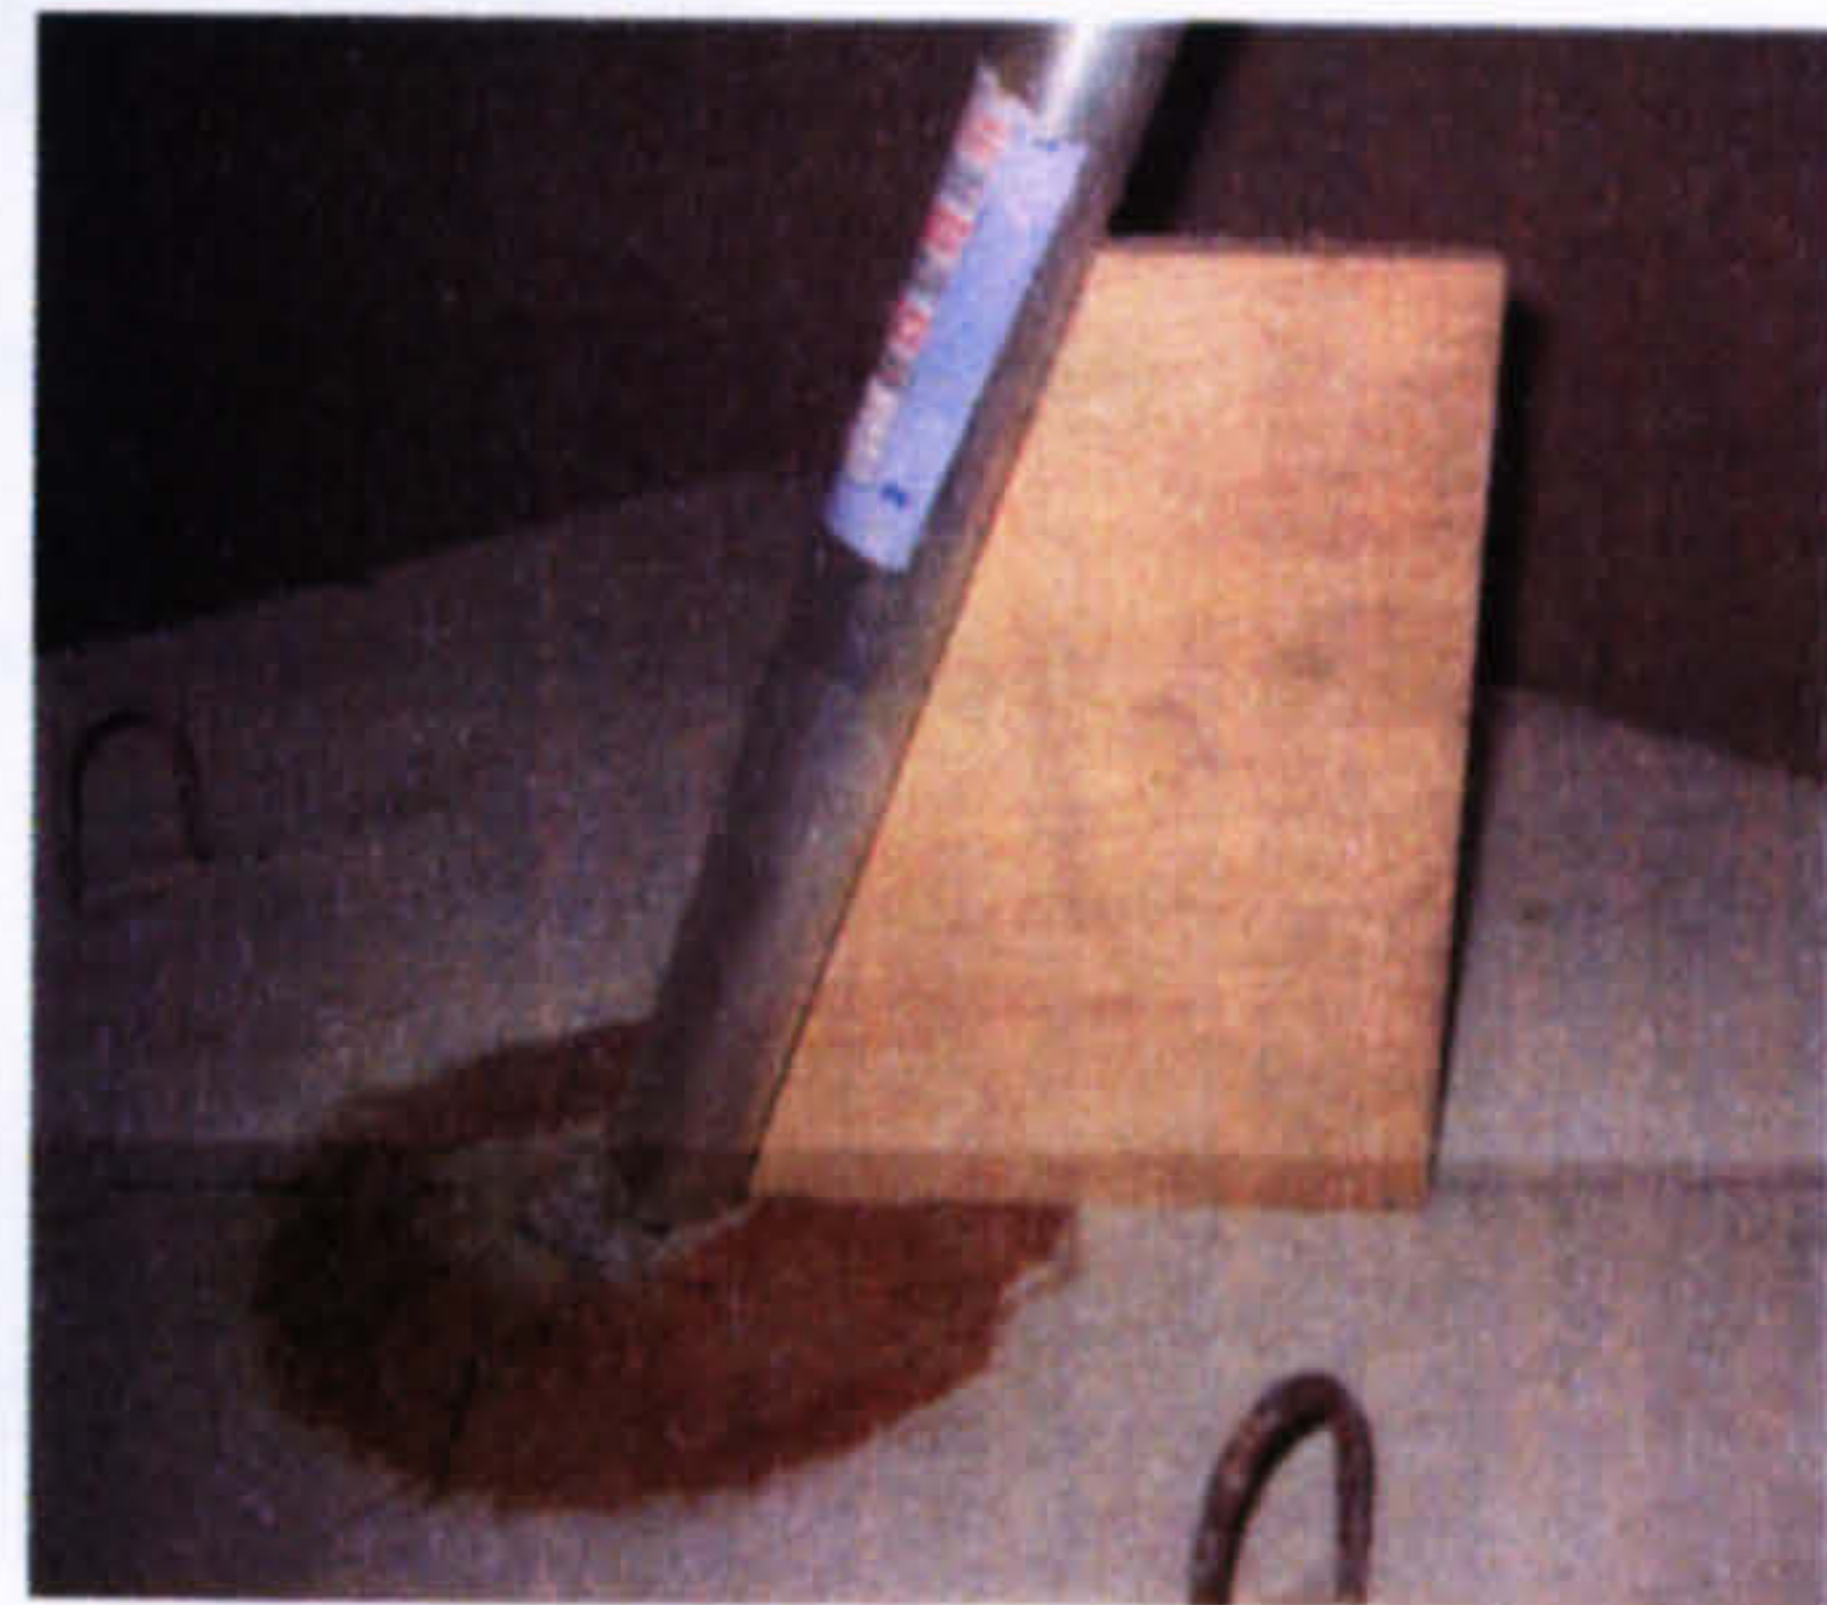
**Plate 3.6.5 Positioning of the charge holder relative to the secondary slab**

Positioning the charge holder

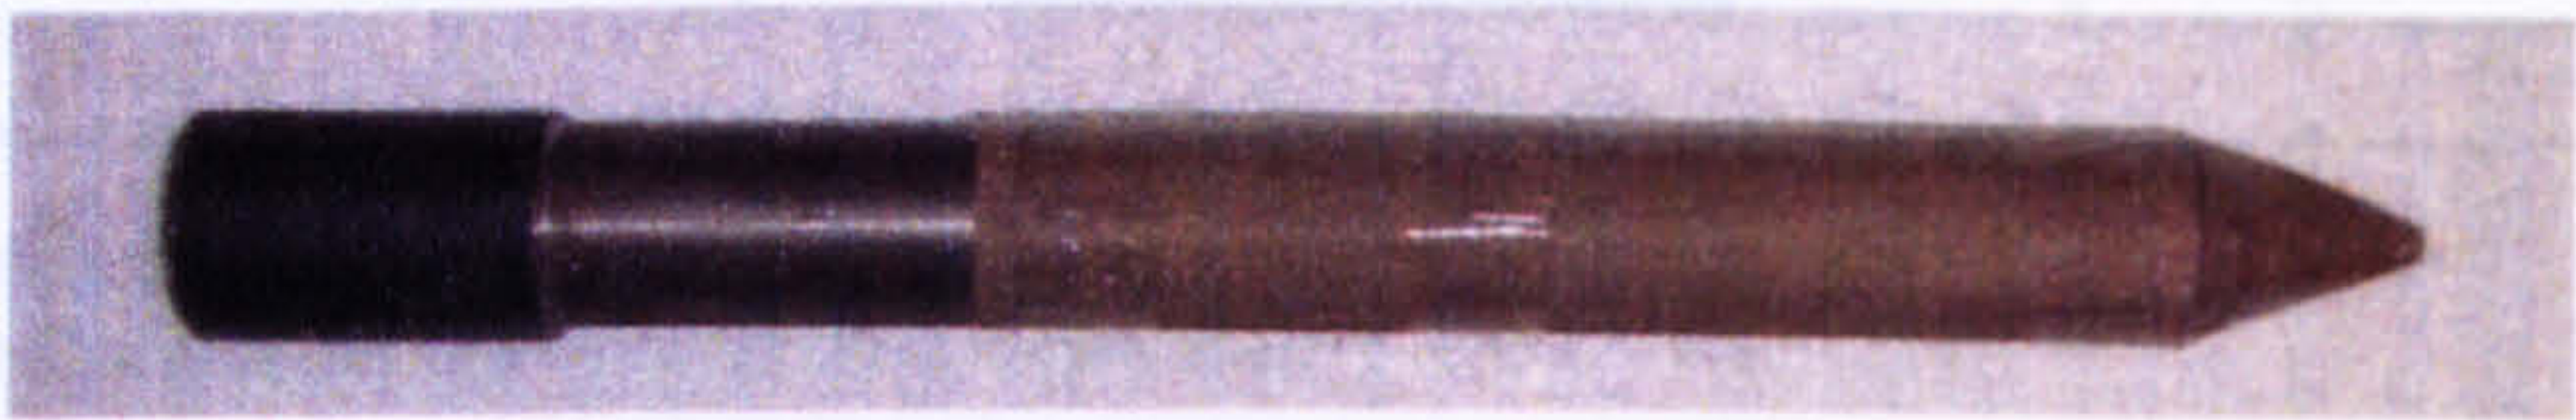
**Plate 3.6.8 Cylindrical charge mould**

A charge template was made from cardboard as illustrated in plate 3.6.8, which was then filled with 183g of PE4.

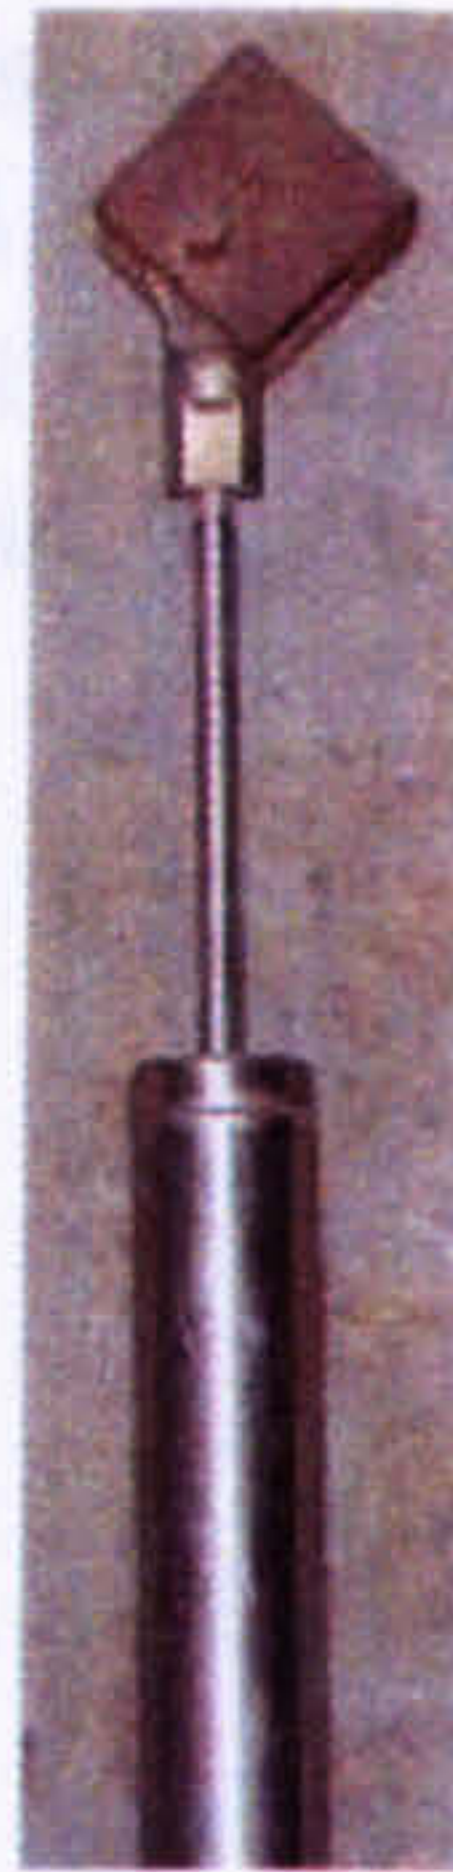
**Plate 3.6.11 Rotational movement of the metal connector**

Metal mountings were attached to each of the LVDTs as illustrated in plate 3.6.11. They allowed the LVDTs to be fixed in a vertical position beneath the bottom face of the primary slab but also giving it rotational stability during the bending of the slab. Without the ability to rotate, a fully fixed position would have caused the LVDTs to bend due to flexure of the slab.

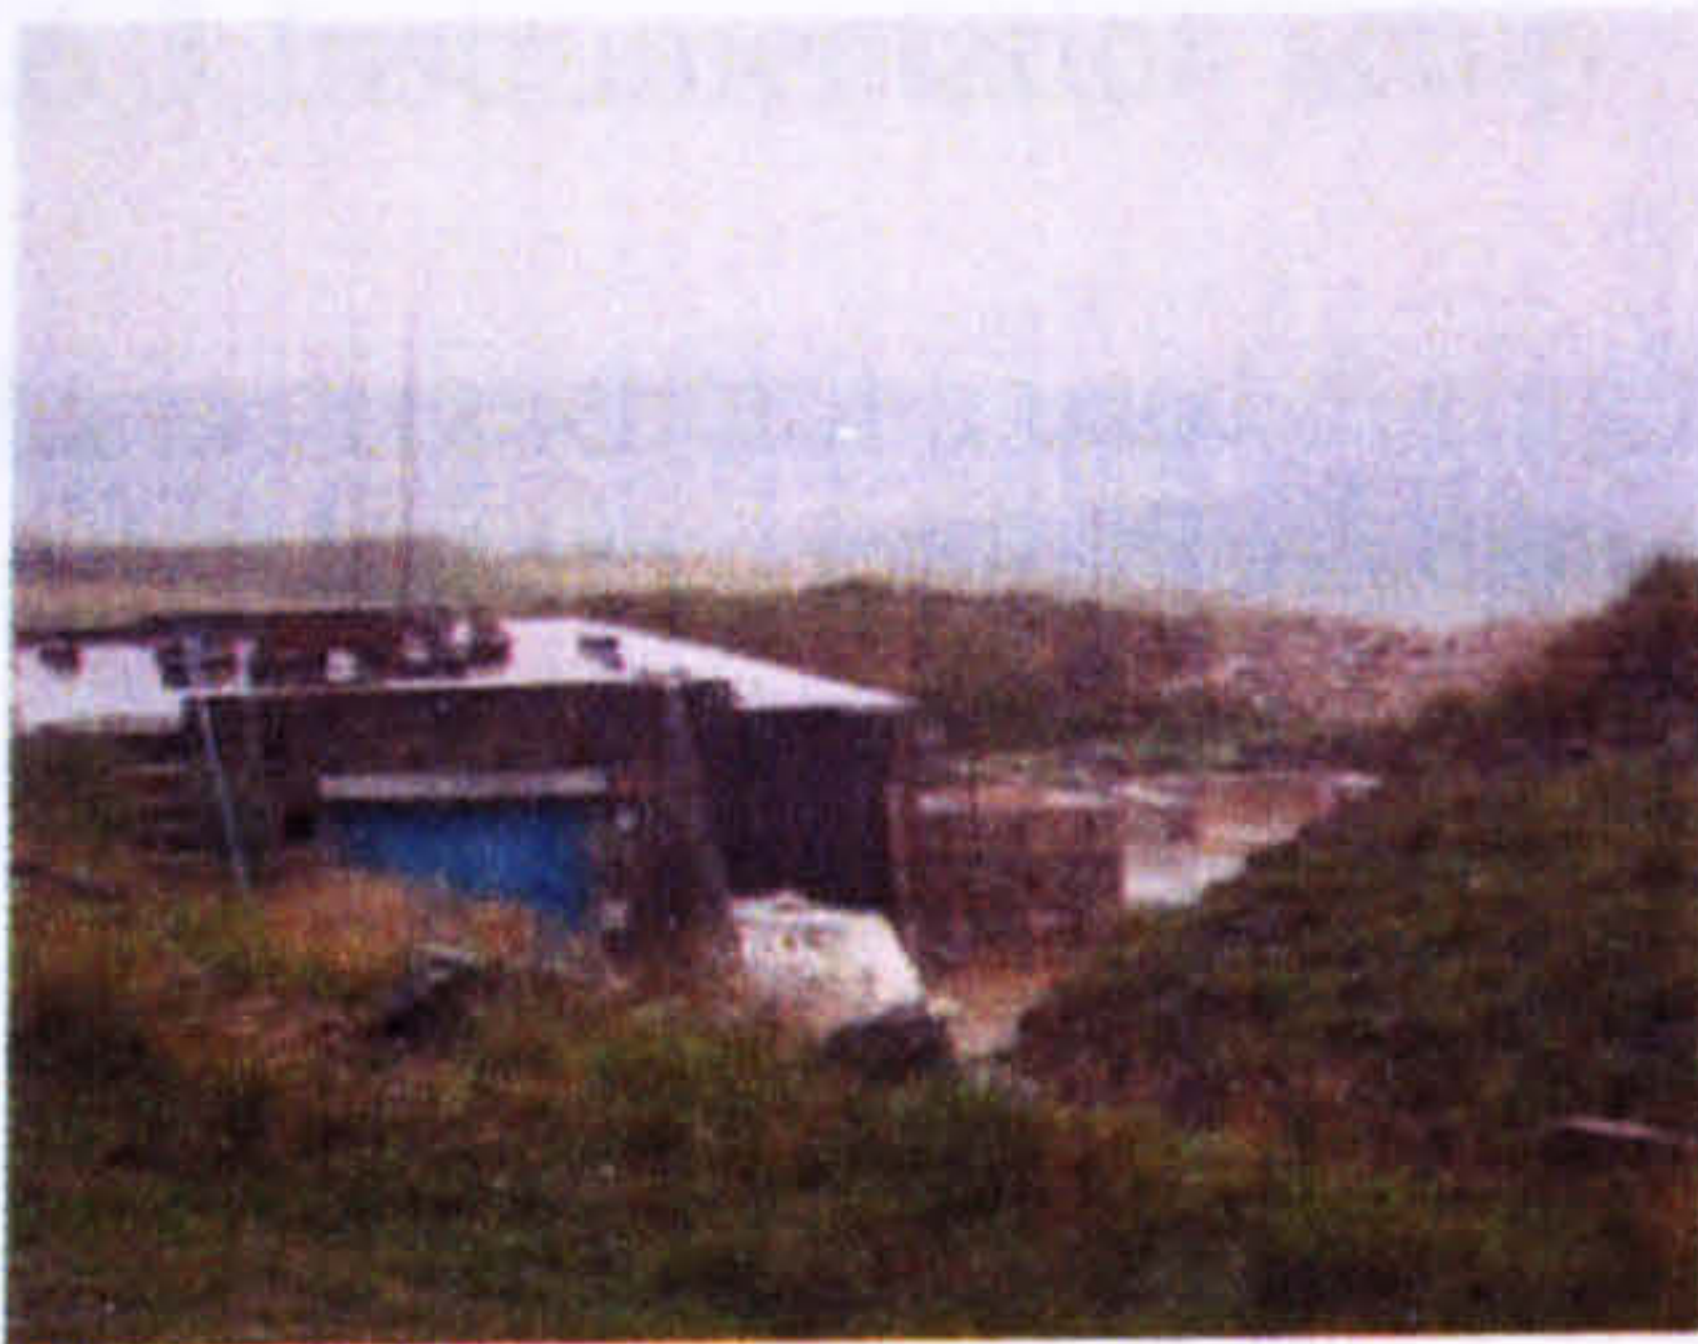
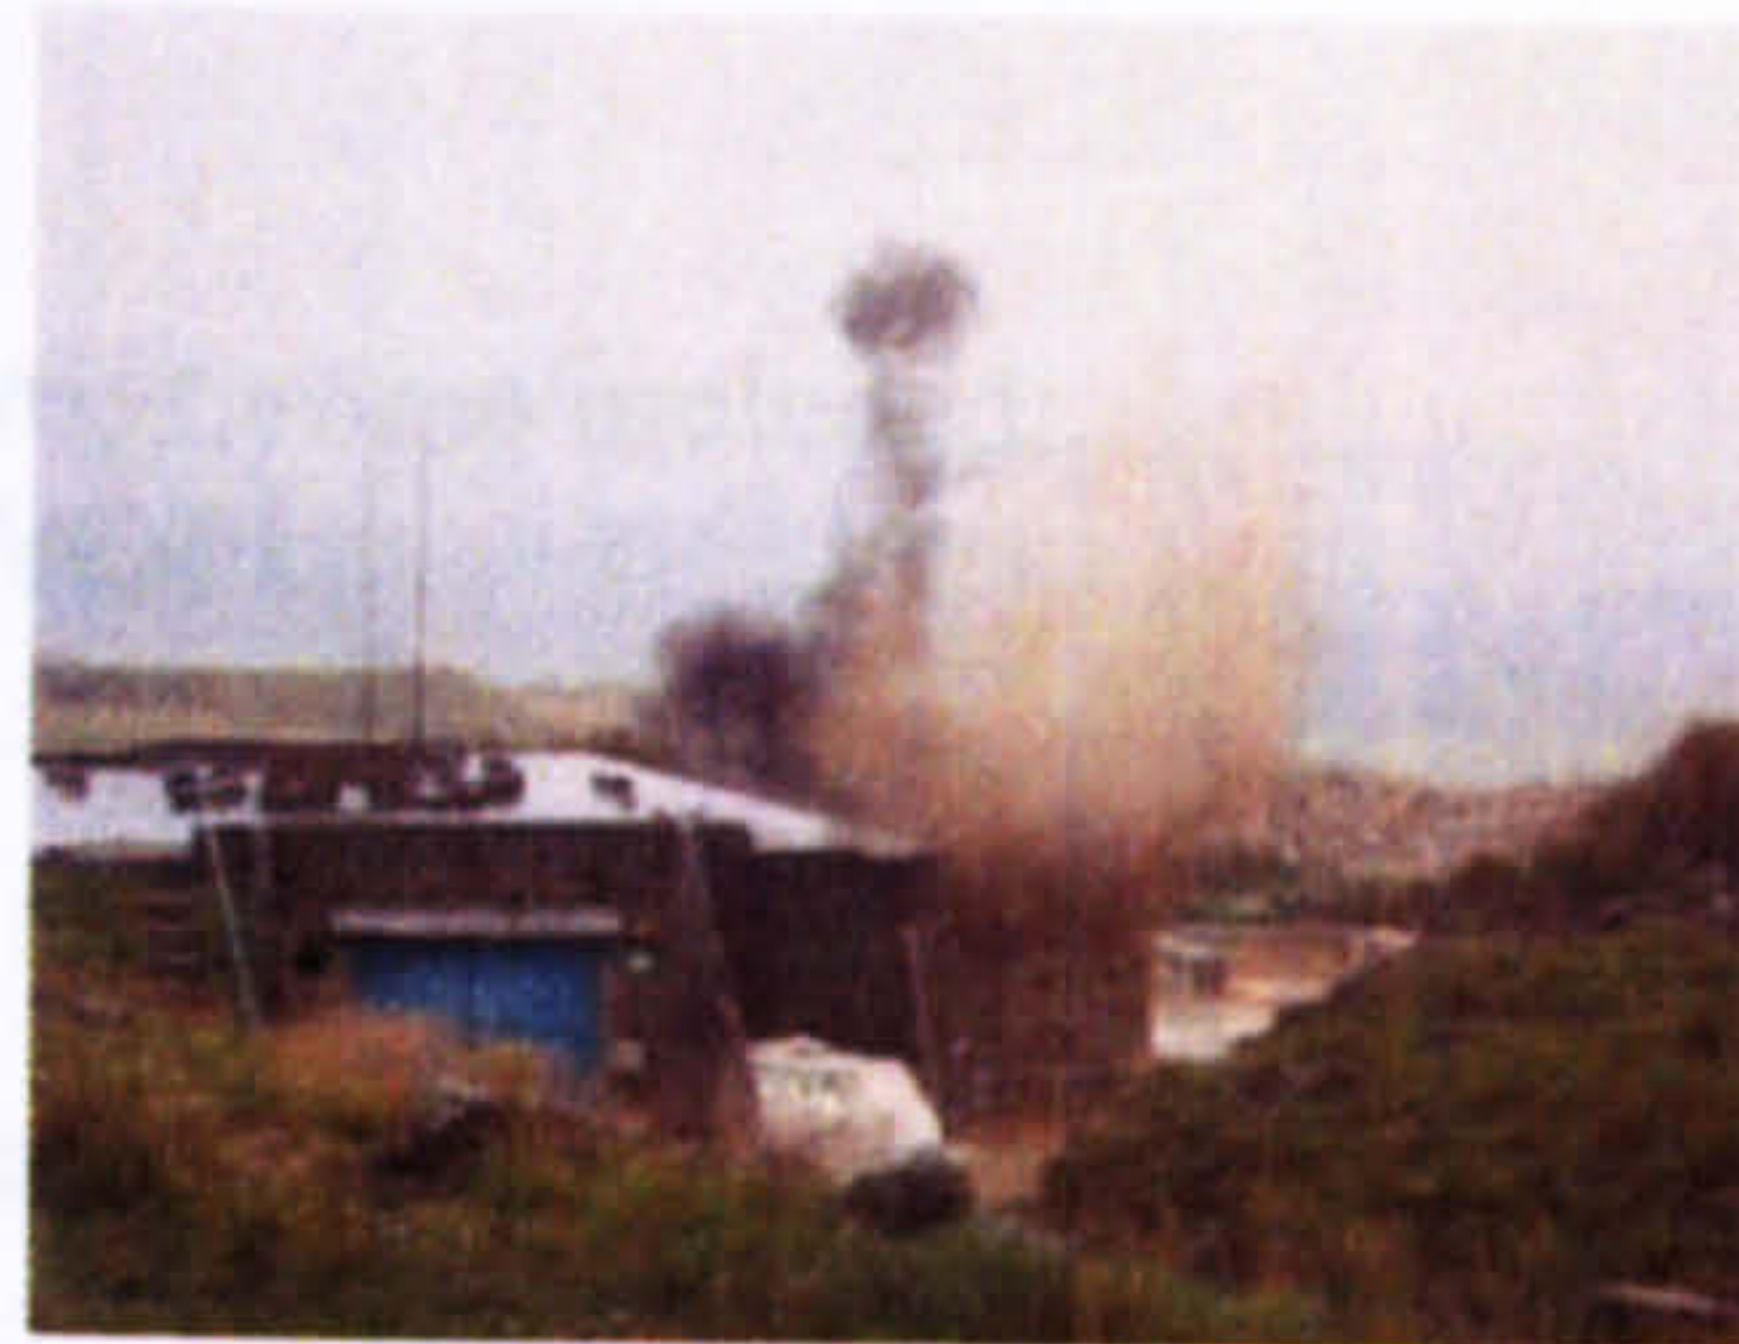
**Plate 3.6.12 Explosion within the test cell**

A typical explosion within the test cell is illustrated in plate 3.6.12 and associated with the removal of soil from above the secondary slab.

Pre-detonation

Post-detonation

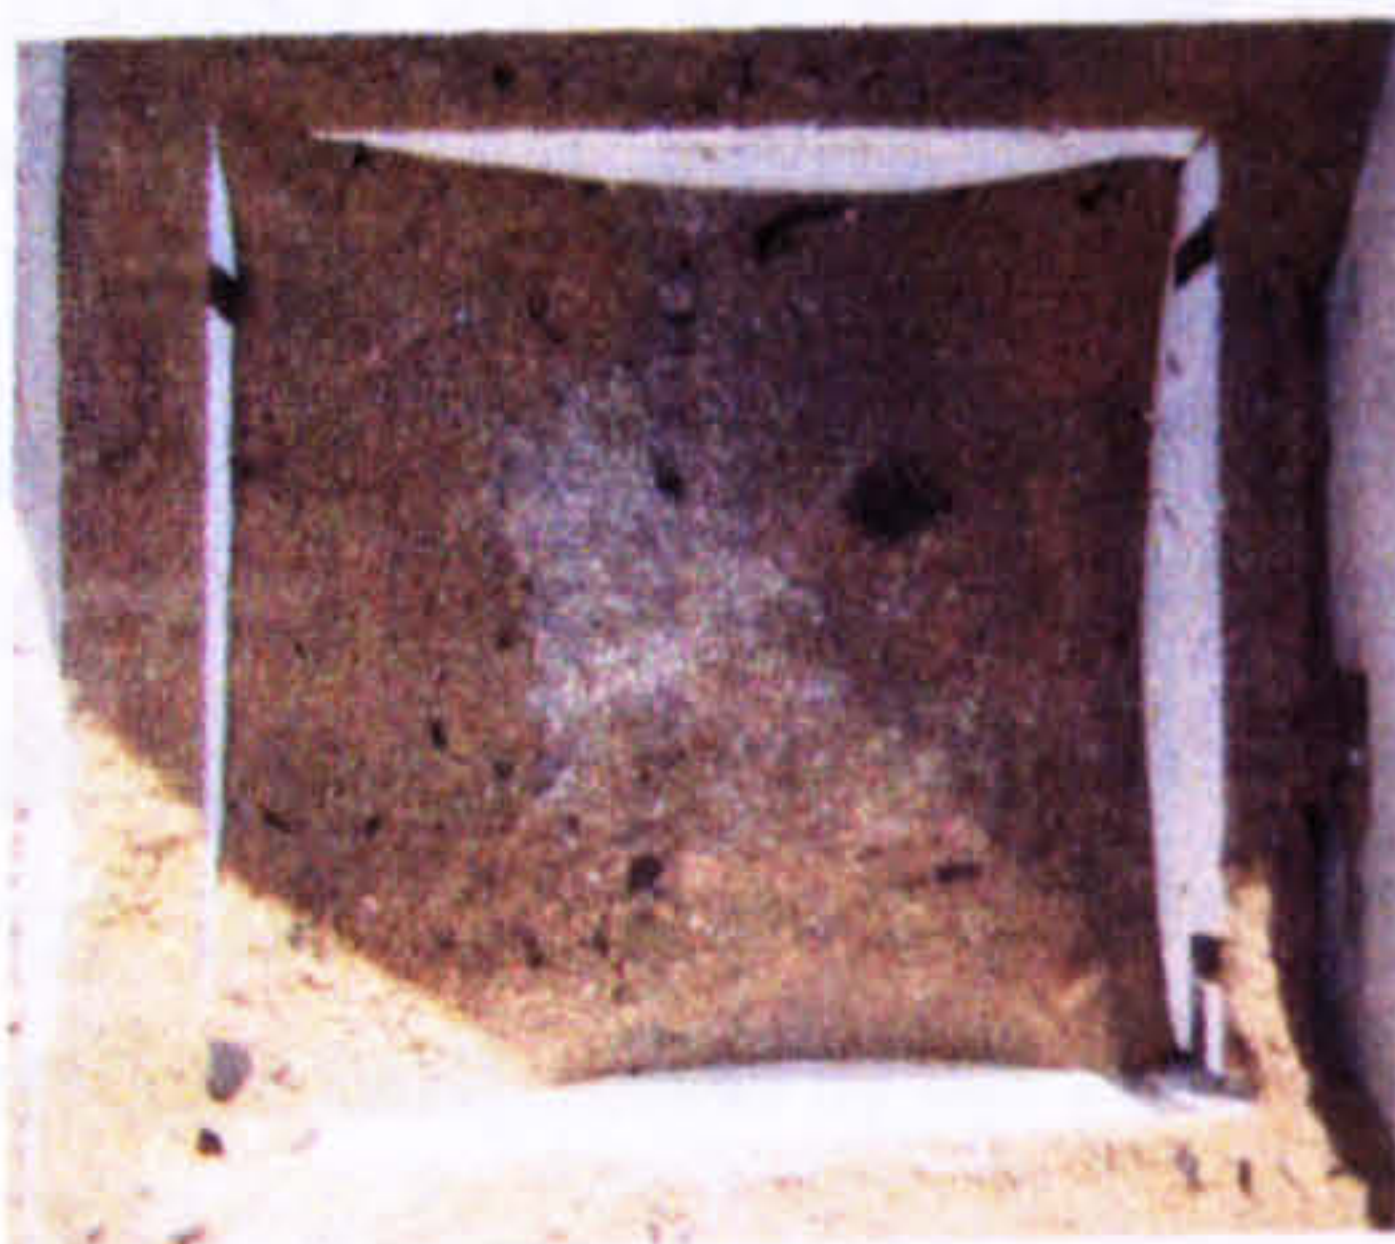
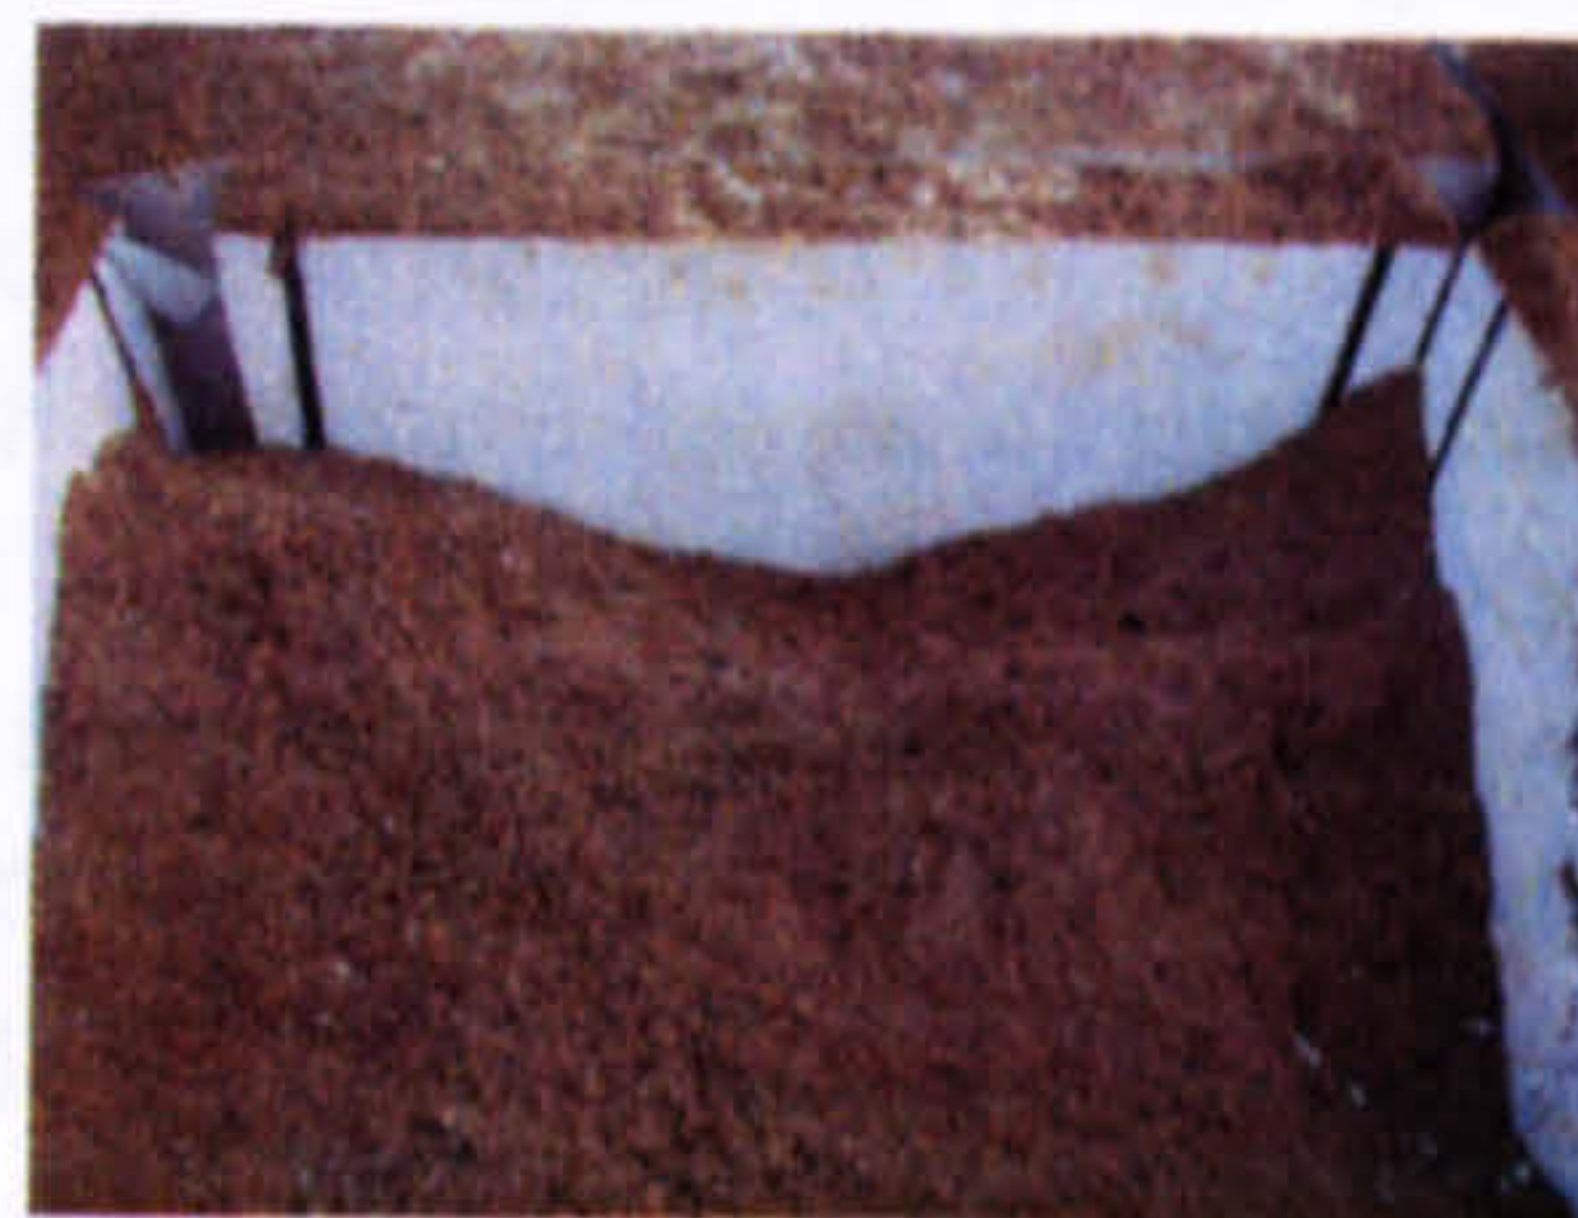
**Plate 3.6.13 Displacement of the soil**

Once the test site was declared as being safe, the LVDTs were checked for damage and the formation of soil craters observed, as illustrated in plate 3.6.13. It was not within the objectives of the research to study the soil craters produced, leaving scope for further work.

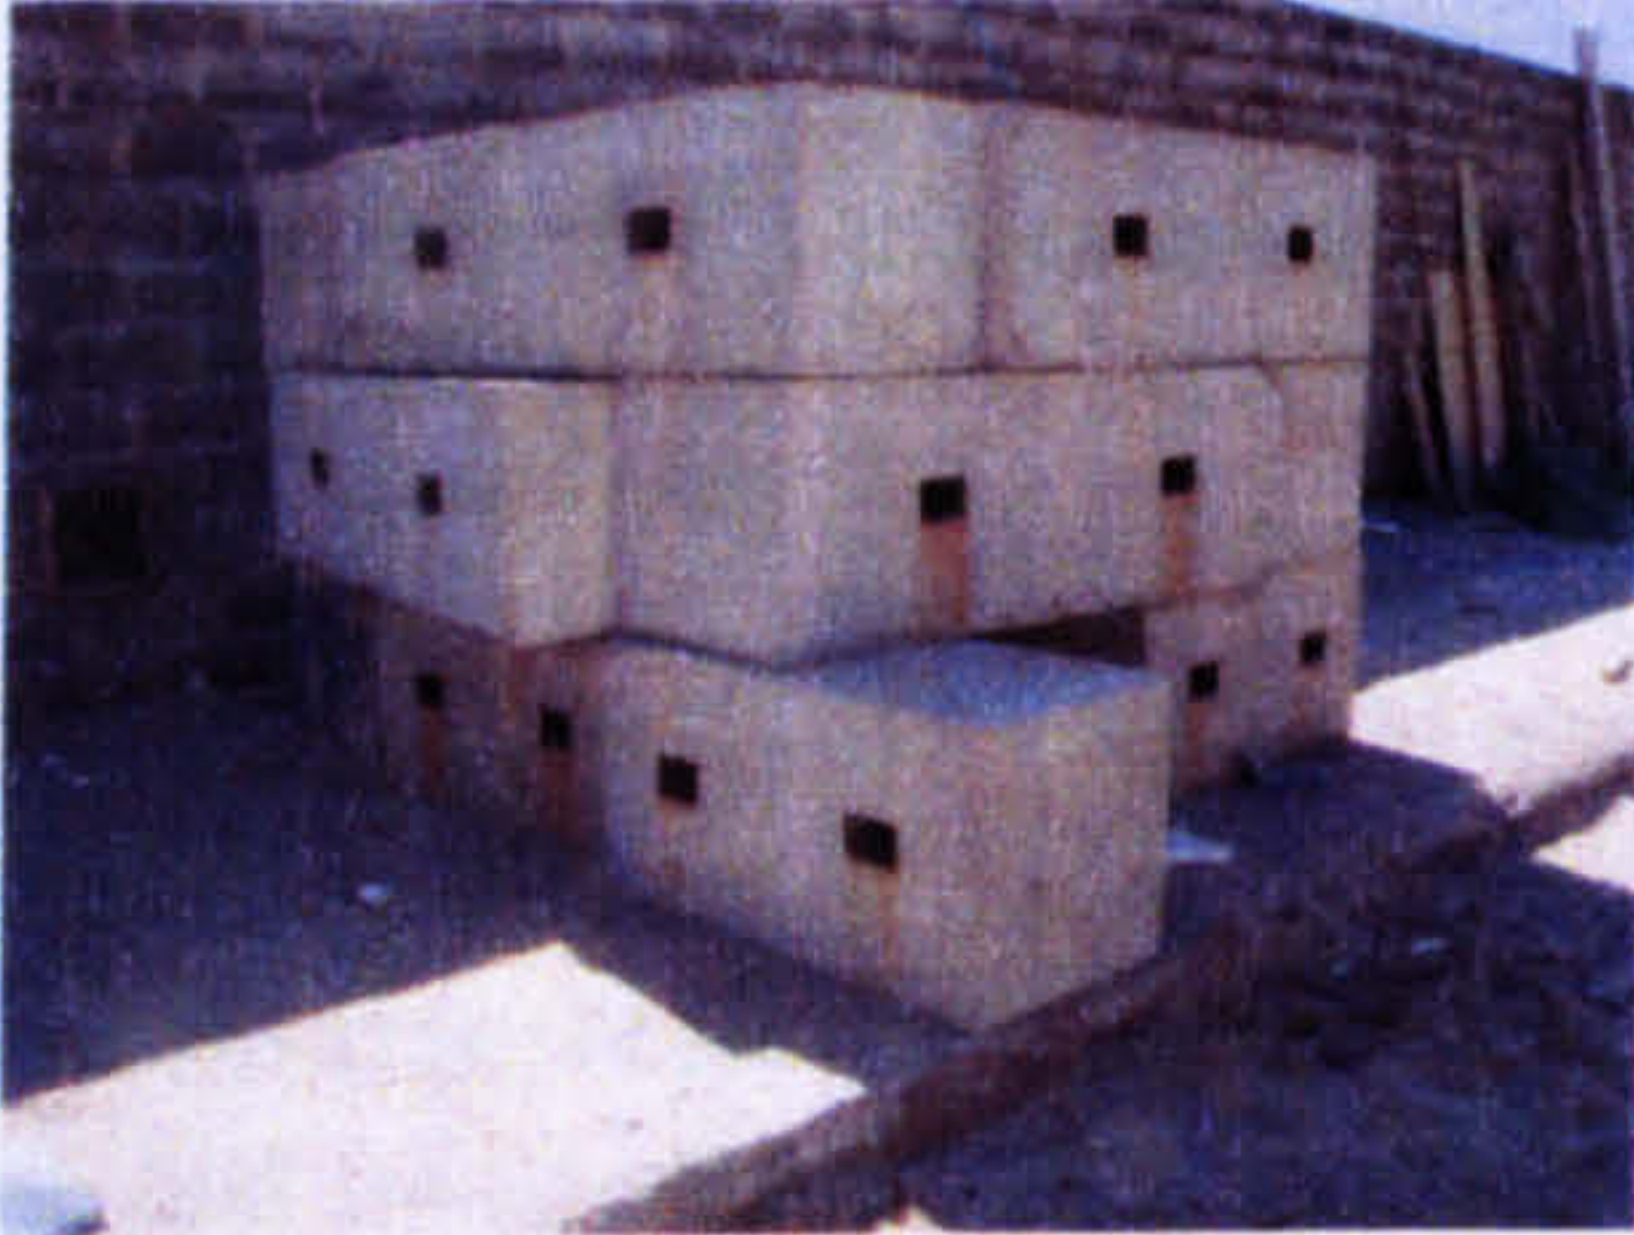
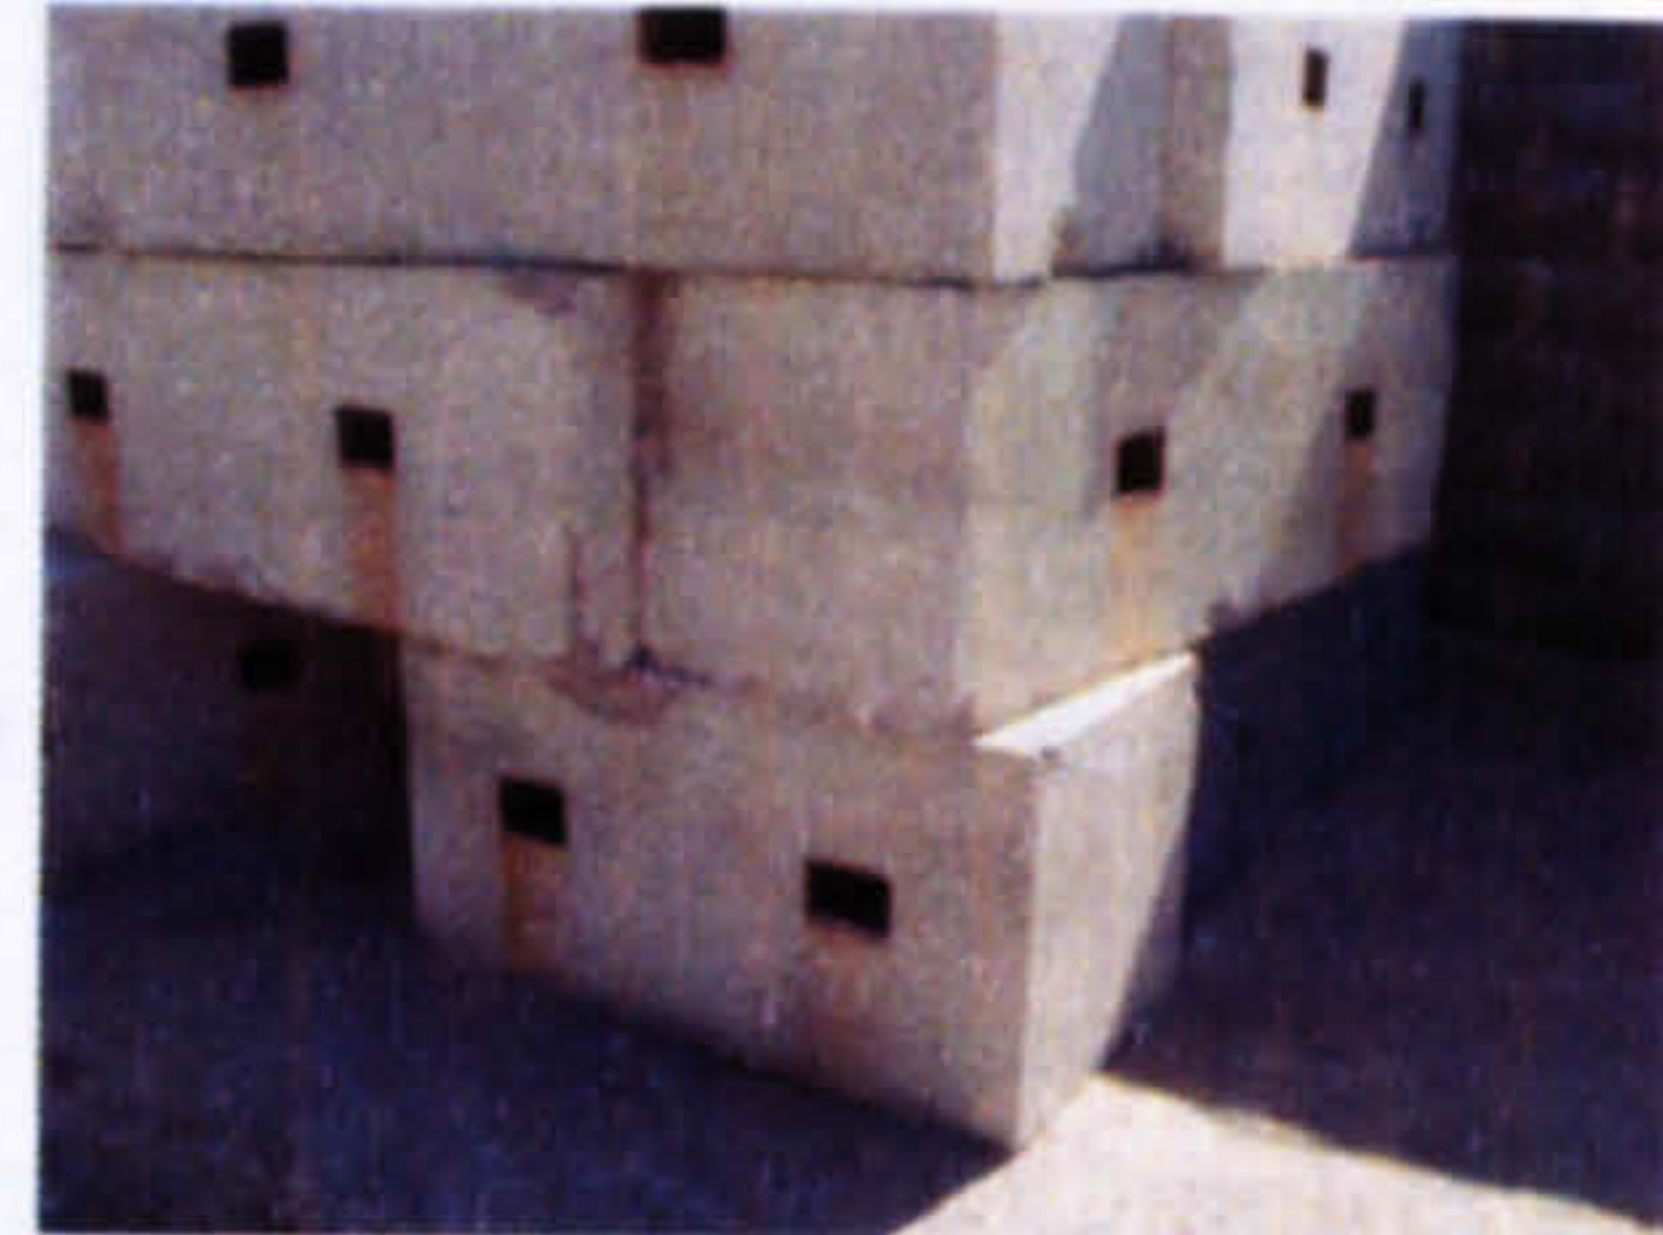
**Plate 3.6.14 Damage to the displaced pendine blocks**

The loading produced within the test cell caused the pendine blocks to displace outwards, as illustrated in plate 3.6.14. Continuous displacement from each explosive test caused cracking of the blocks, but still ensured structural integrity. The displaced blocks had to be manoeuvred back into position prior to each test, which was a time consuming operation.

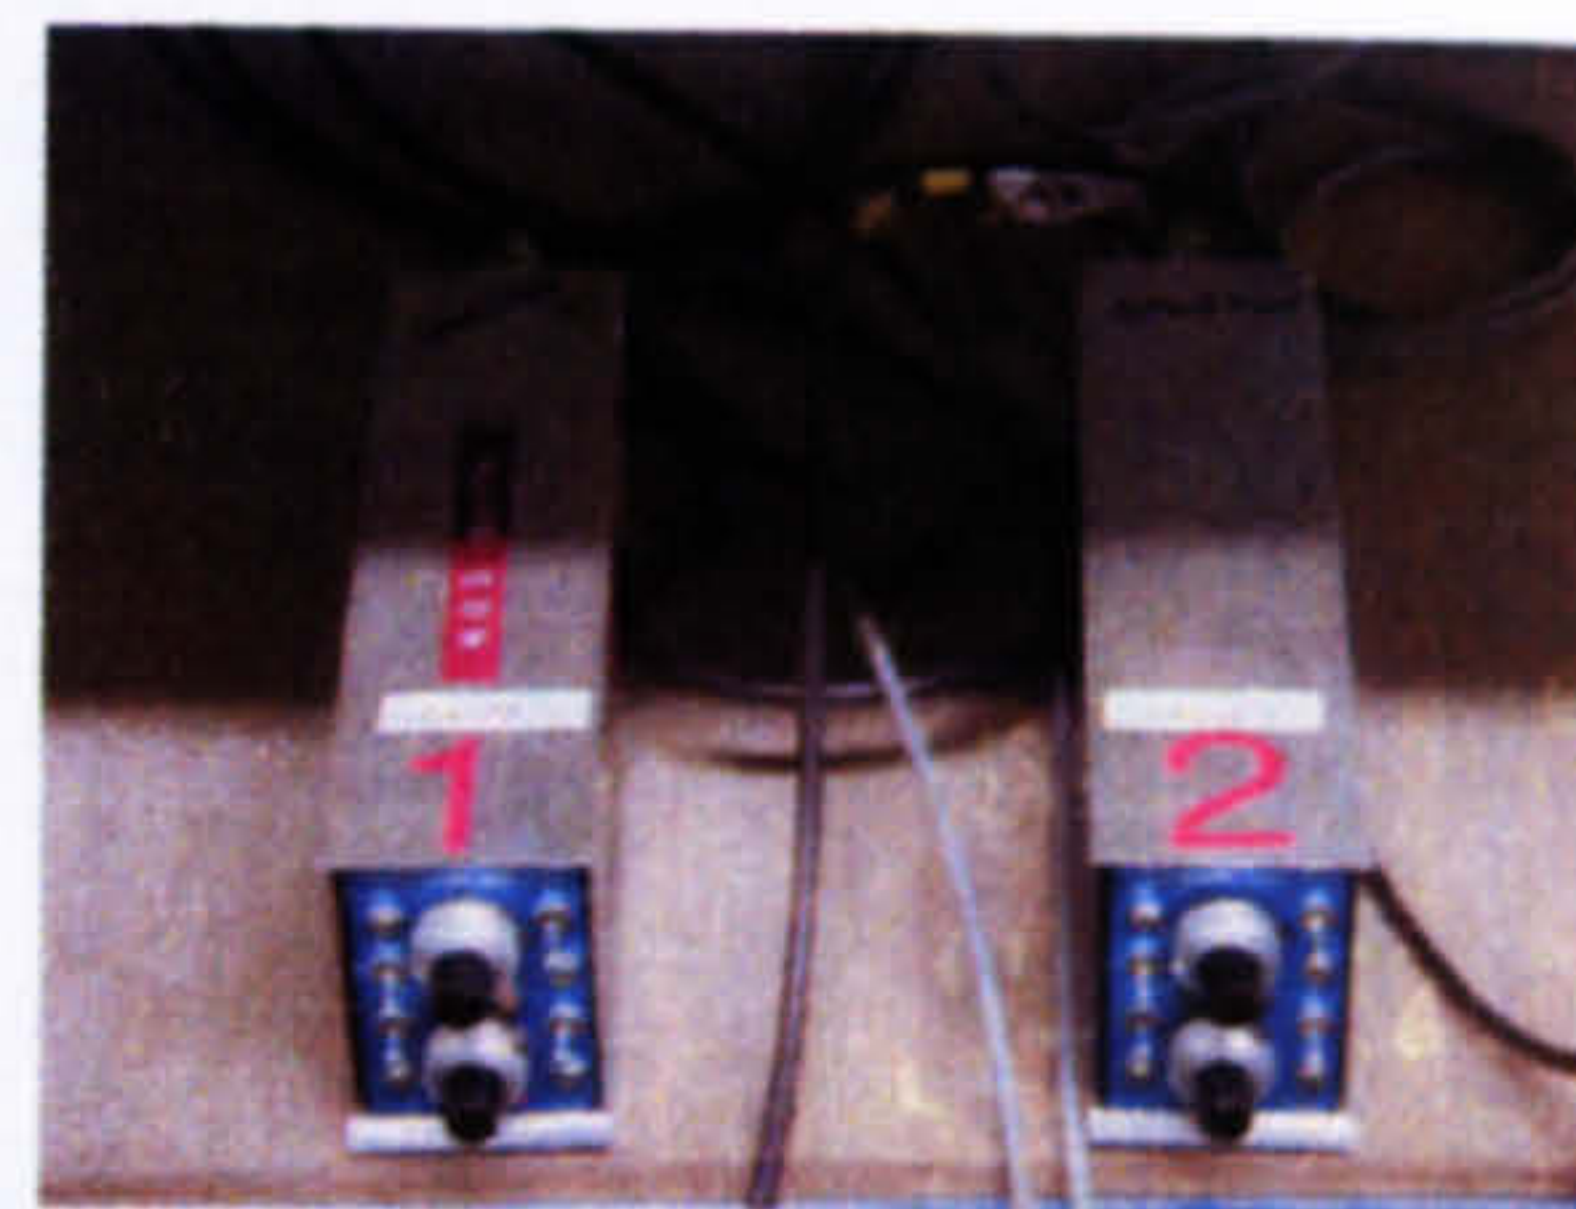
**Plate 3.6.15 Electrical appliances used to construct wheatstone bridge circuits**

Bridge transducer amplifiers

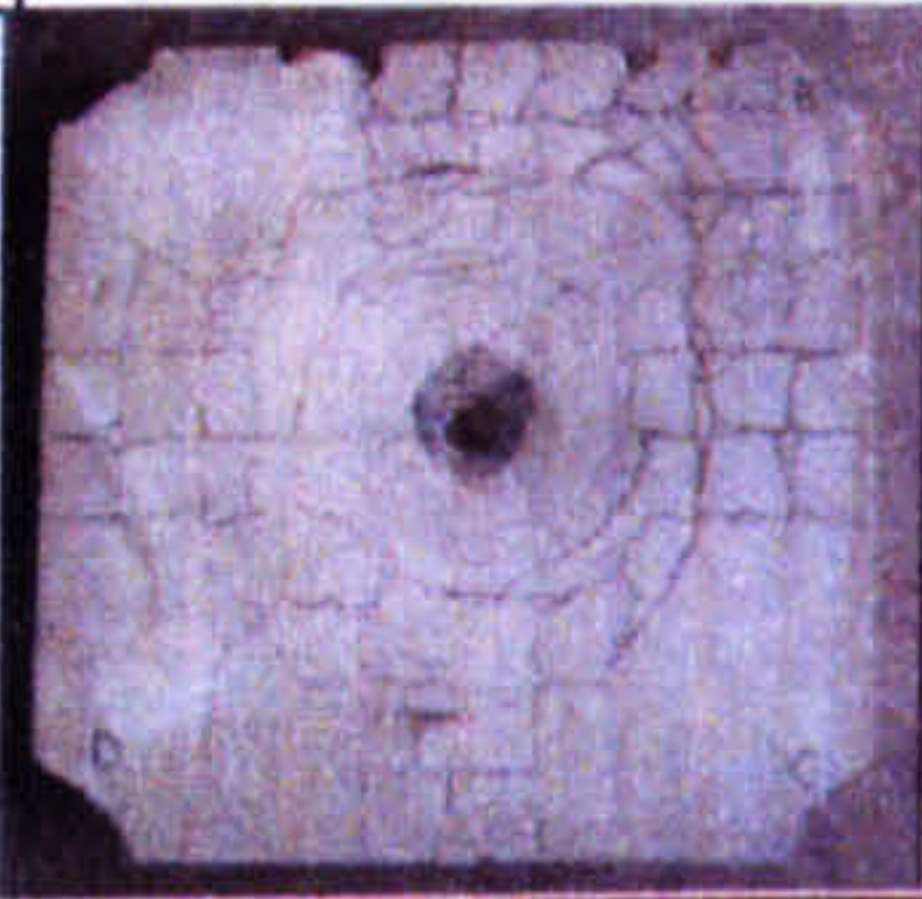
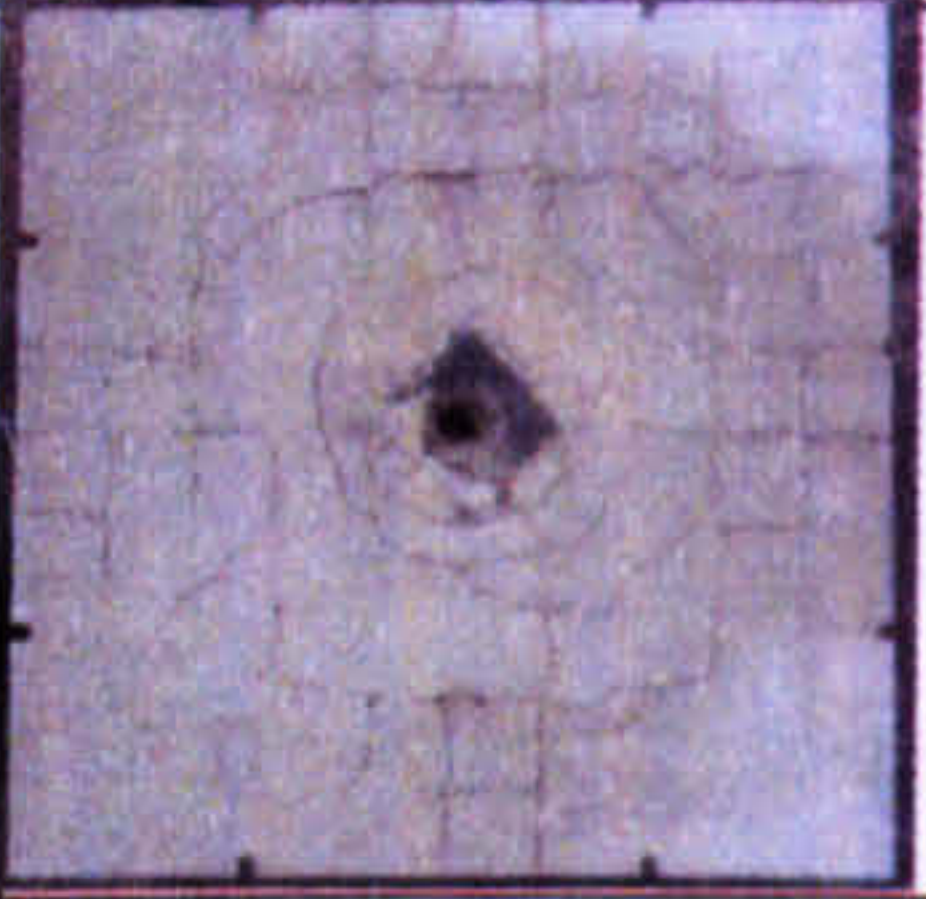
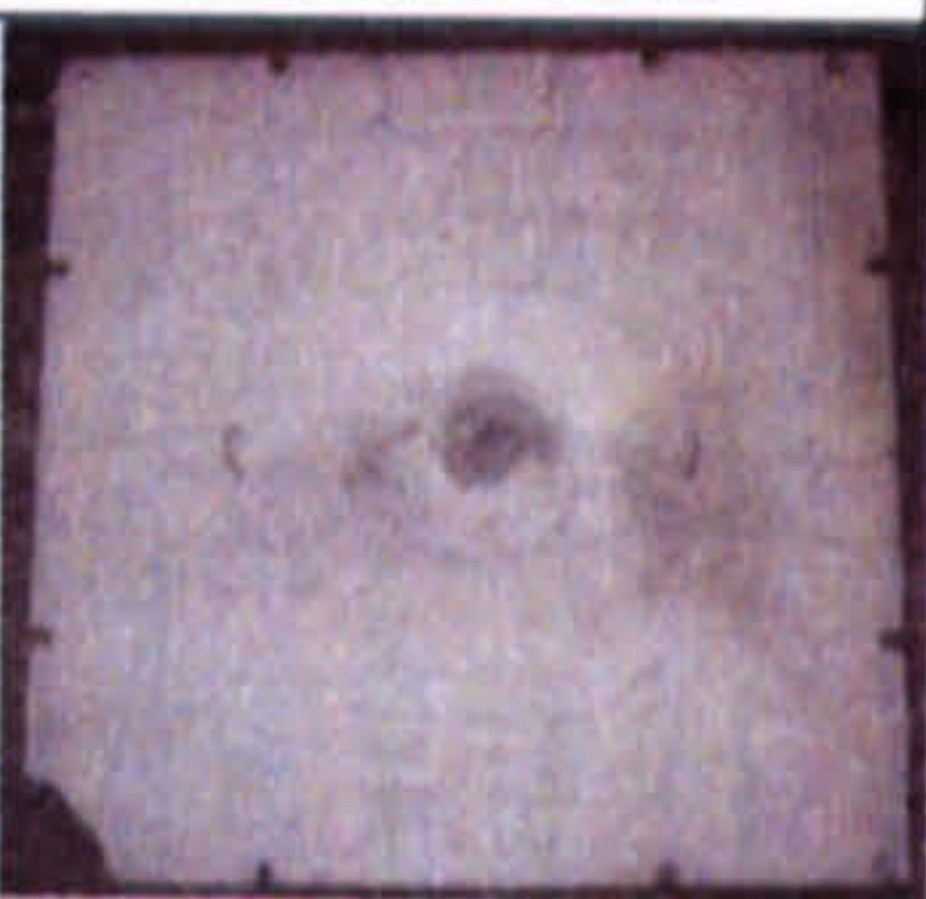
**Table 4.2.5**Top face of secondary slabs with radial and circumferential cracks

RCB73IT1	RCB73IT5	RCB73IT9	RCB73TI12
Top face of secondary slabs caused by charge position A
